1991 STUDY

1991 HAMILTON  
TRAFFIC OPERATIONS  
STUDY

CITY OF HAMILTON, MONTANA

MARVIN & ASSOCIATES

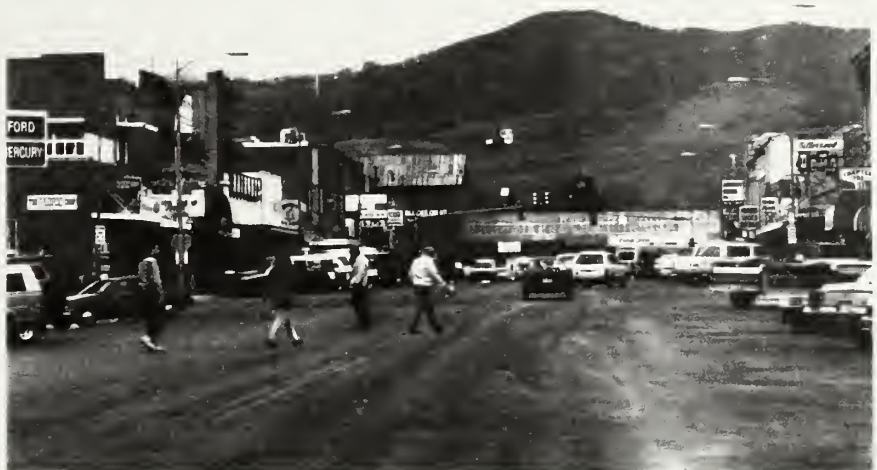
Note jay walkers!

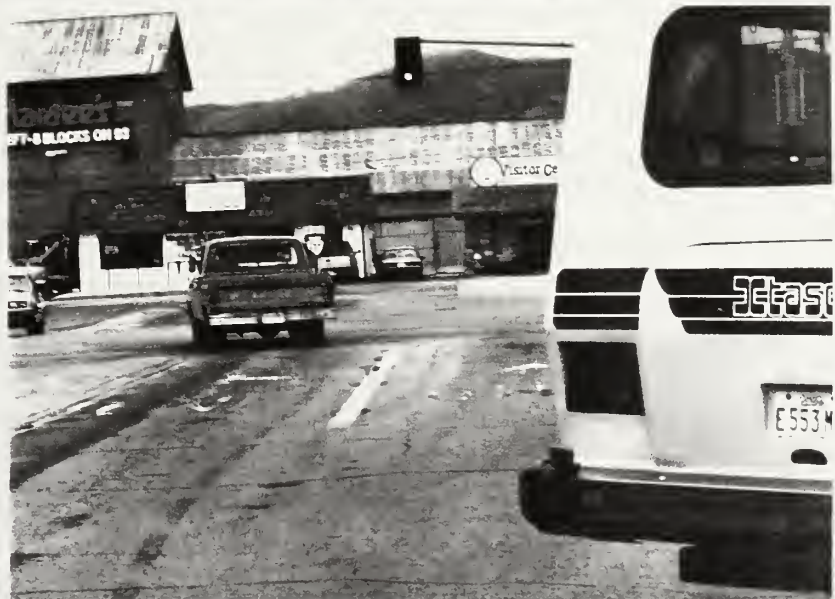
A 35' RV is angle parked (legally) near intersection with First Street. There is a right turn lane on the other side of the RV. One and a half lanes are blocked.

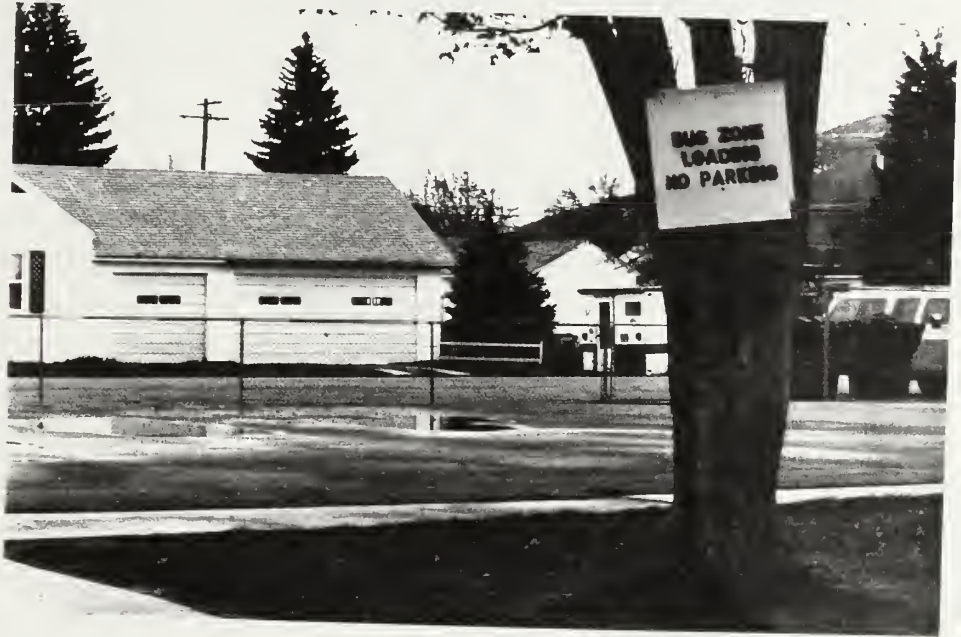
Home made sign with solid mounting. Its too far from the street and cannot be taken seriously.

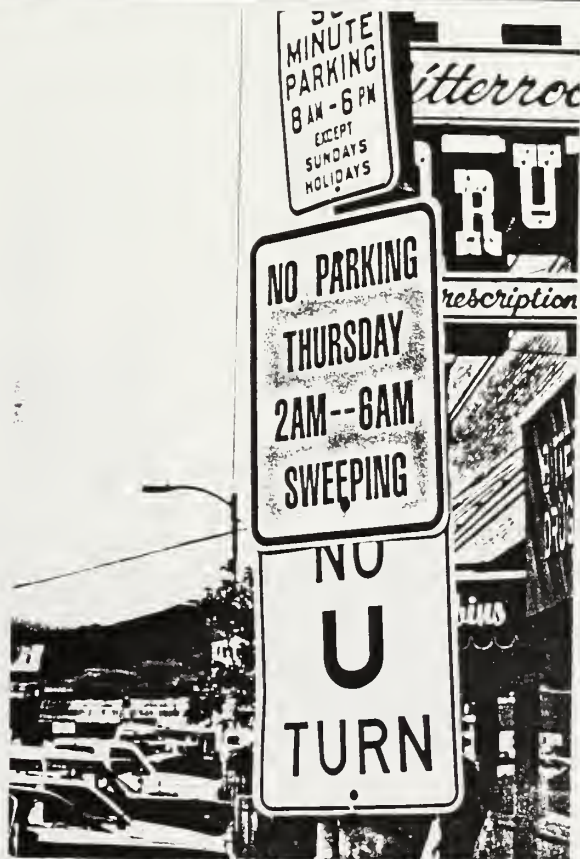
Standard parking signs combined with regulatory sign on the same pole. Signs overlap and cover message. Sign is too far from street to be read.

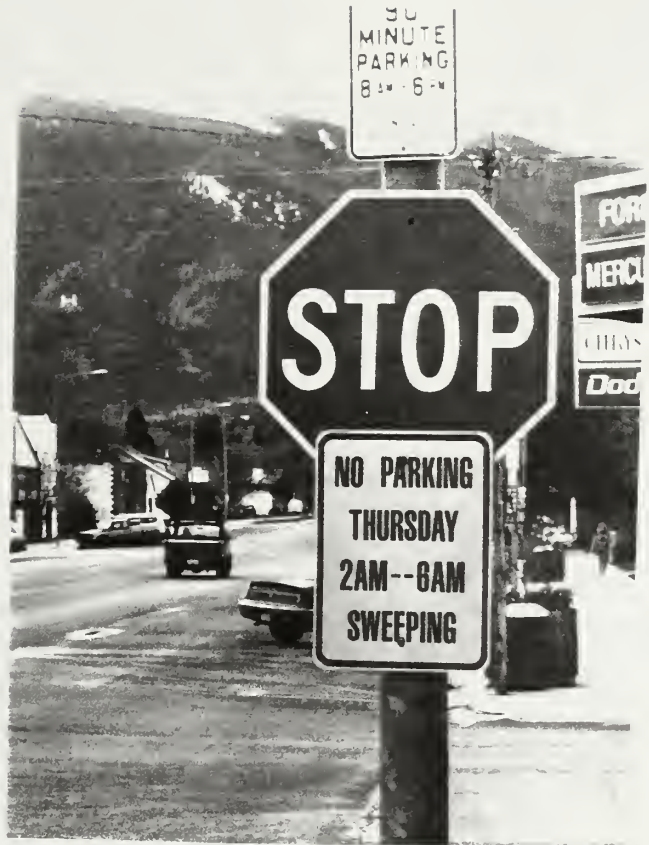
Too many signs on one pole leads to overlaps. While no legend is covered, the basic shape of the stop sign is altered. For those with failing vision the shape assists in immediate perception.

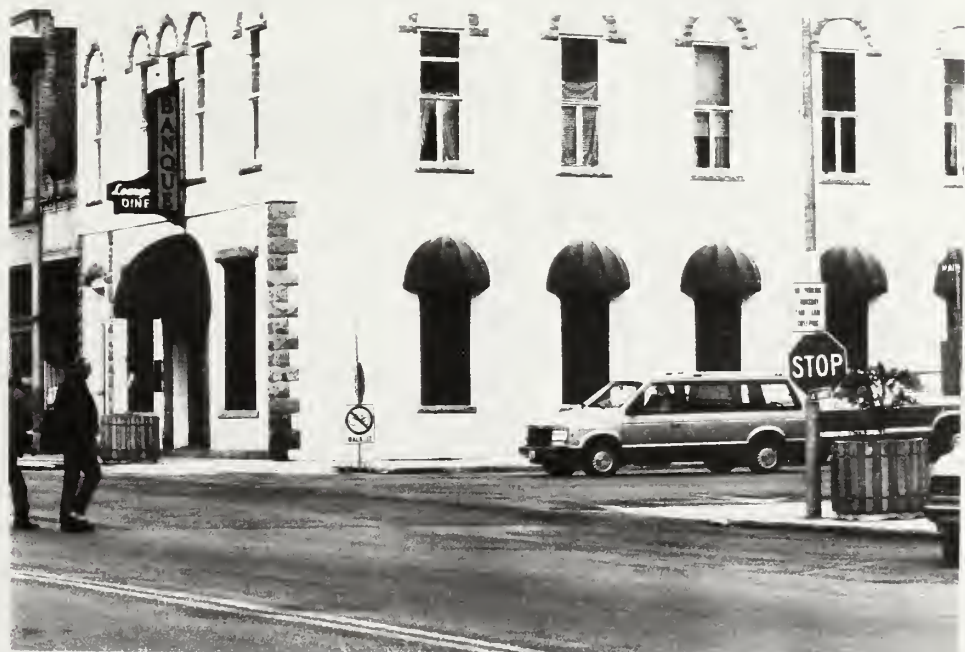
Mounting height of signs is important, for driver visibility and pedestrian safety. Signs on far corner, look as if they slid down the pole. Pedestrians could walk into it and injure themselves. They are almost invisible from the drivers view.

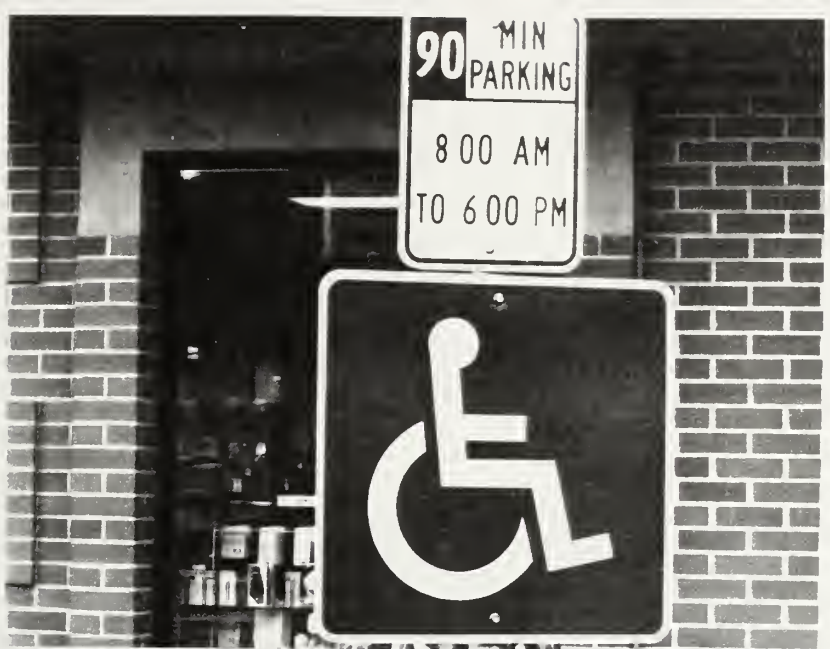
Combination sign does not provide clear message. Is it 90 minute parking only for the handicapped?

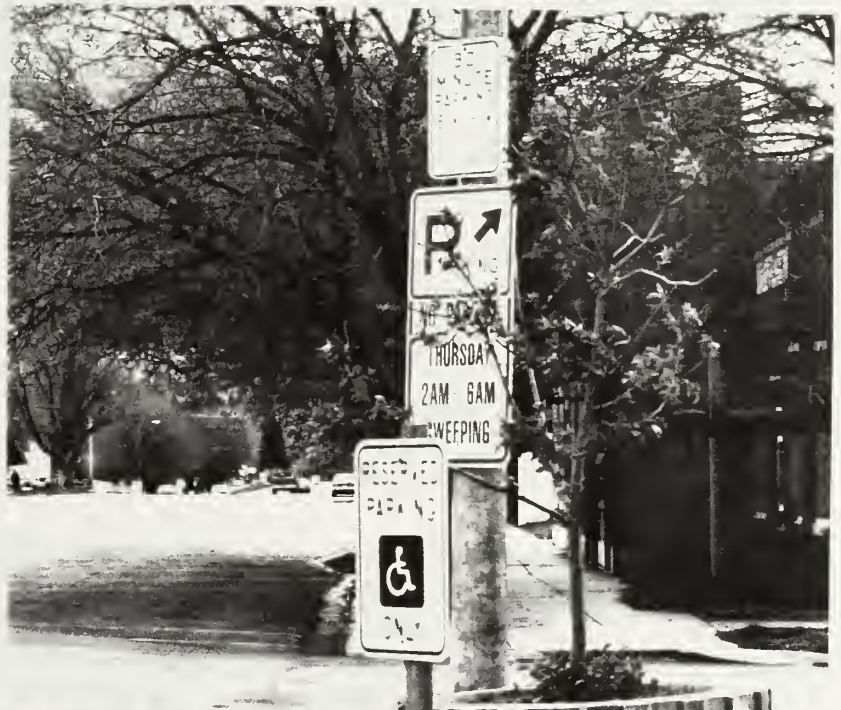
Where can a person park around here? Fortunately, three of the signs will be hidden when the tree grows.

This sign may be able to replace the four signs in the above photo.

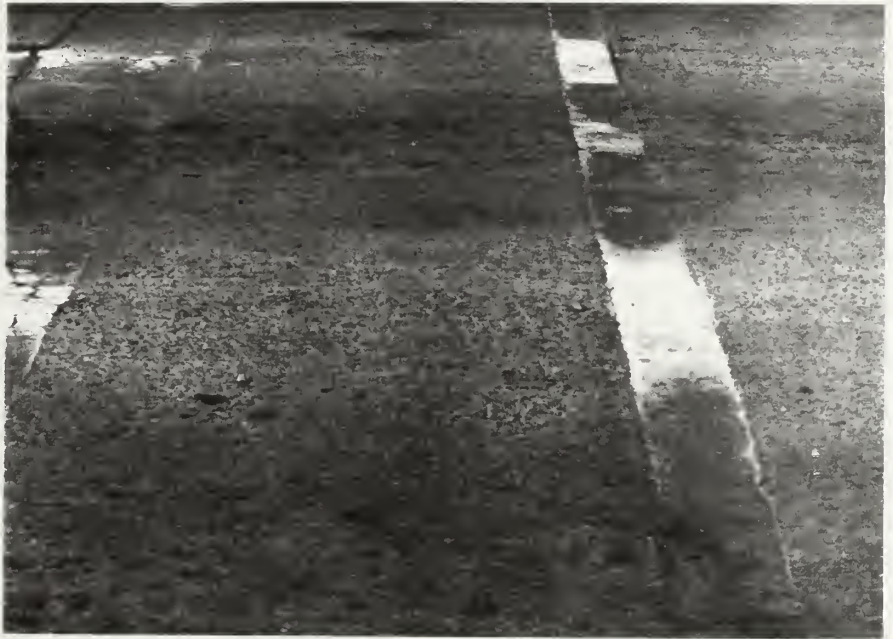
Plastic markings at Main and US 93 have worn badly and are barely visible.

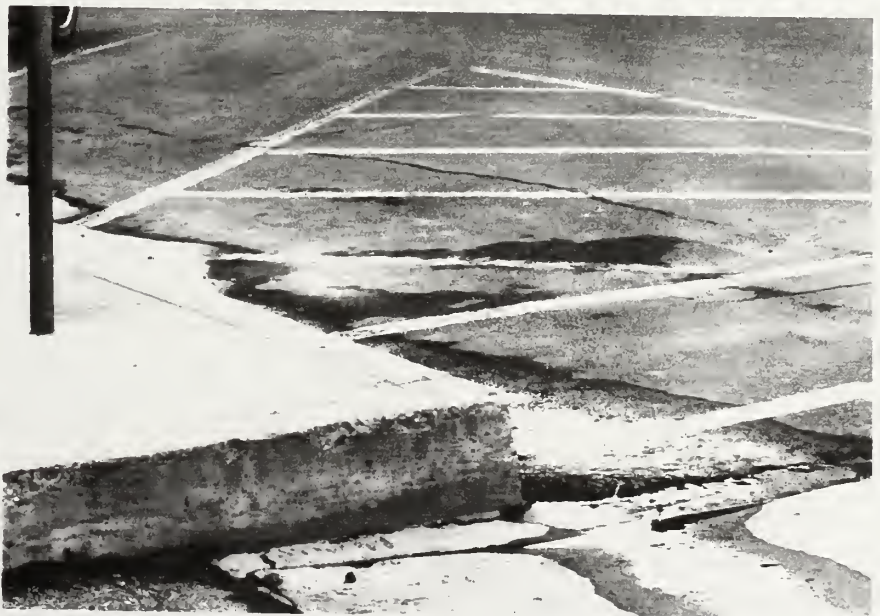
Parking restrictions, marked at intersections, are a good attempt at controlling the corners for sight distance and pedestrians. Note sharp curb point. It is hazardous for turning vehicles and reduces the distance of the actual parking setback.

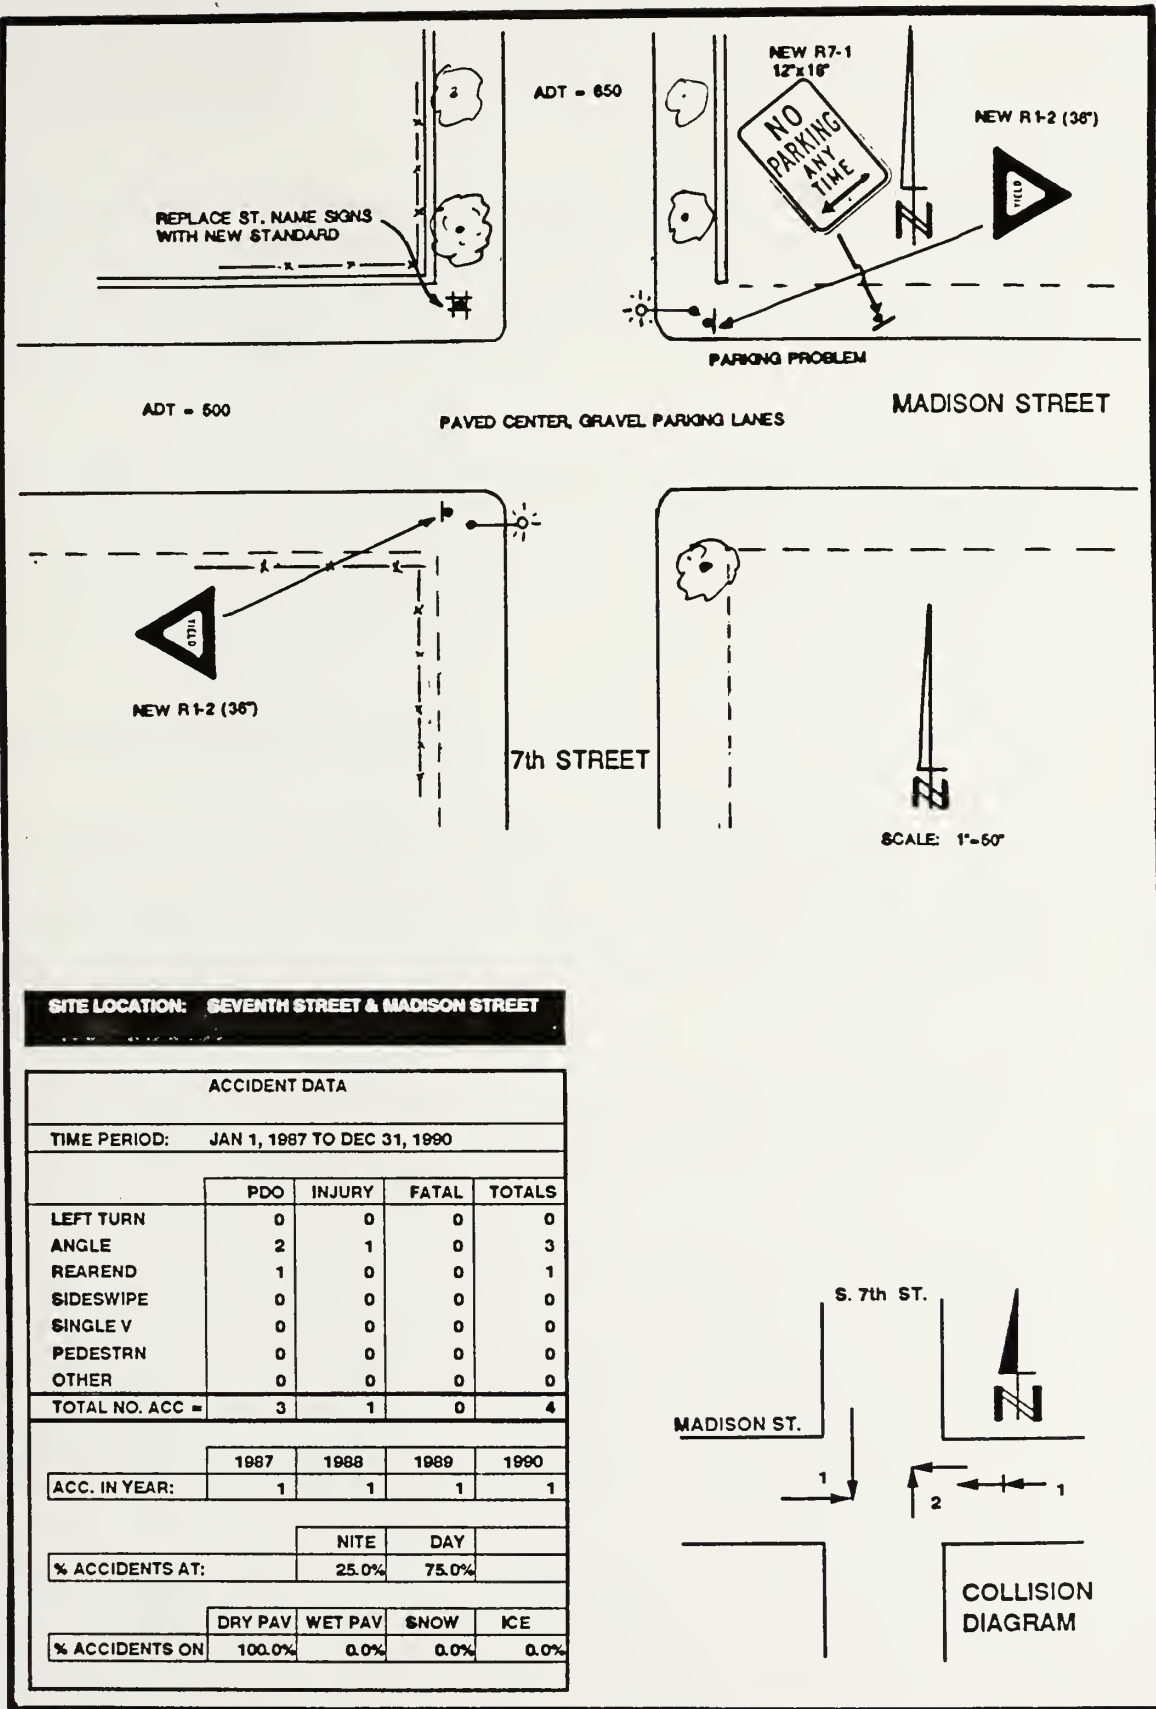
**FIGURE NO.**  
**VI-3.**

Figure VI-3. presents the existing conditions and recommended improvements at this intersection. It is an intersection of two local streets with approximately the same traffic volumes. Both streets are paved in a fashion that is fairly typical in Hamilton, a center strip of paving approximately 30' wide exists with wide gravel parking lanes. In this case there is no curb and gutter, but some sidewalk sections exist. The wide gravel parking area presents an opportunity for vehicles to park in any manner desired and it is difficult to delineate corner parking restrictions.

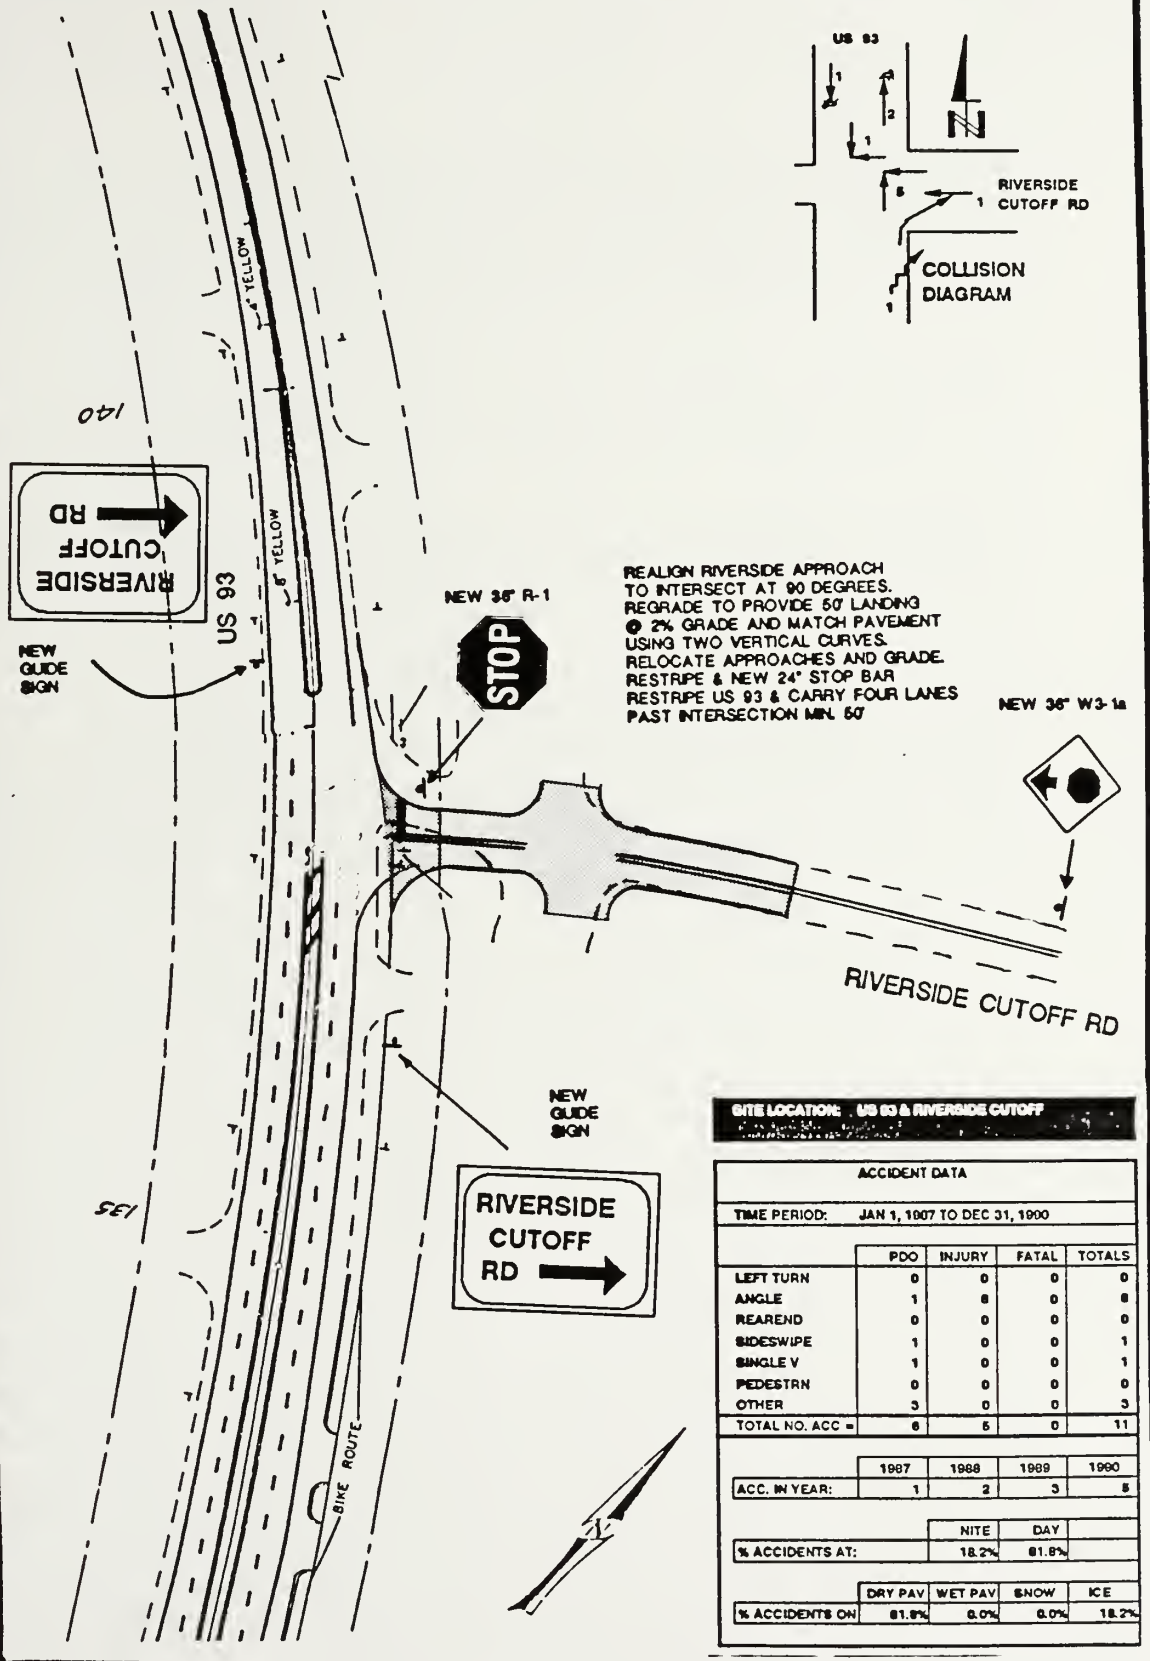
FIGURE NO.  
VI-5.TITLE: RIVERSIDE CUTOFF RD & US 93  
IMPROVEMENTS

Observations indicated that the intersection approach from Riverside Cutoff Road gives no physical clues to the location of the intersection because of the grade and wide approaches on either side. The angle of skew at the intersection is slight enough to ignore, but severe enough to require adjusting the vehicles position to avoid a blind spot. The most noticeable problem is the lane drop caused by the transition at the intersection. It almost appears as if the outer right lane is an exclusive turn lane, which may be a cause of some accidents involved in pulling from the stop into the path of vehicles in the right lane. In addition, northbound thru vehicle drivers on US 93 are occupied in trying to move to the inside lane at this point and are inattentive to vehicles that may be entering from the side road.

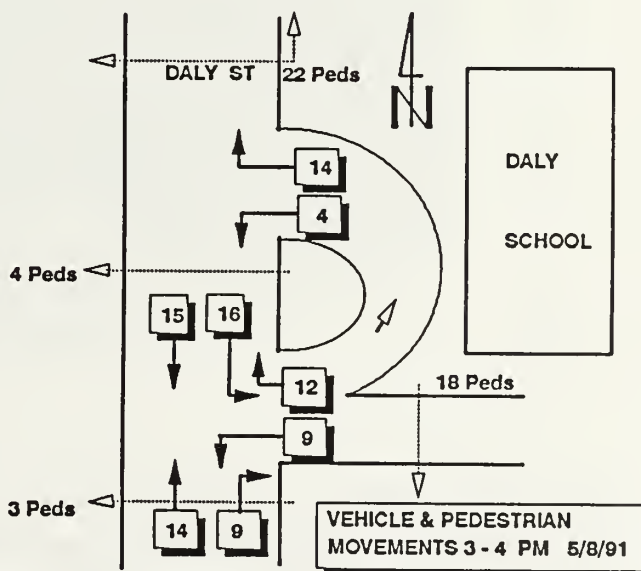
Eighteen peds had to cross the wide, hidden approach.
